INDOOR AIR QUALITY ASSESSMENT

**Grace Baptist Christian Academy
1000 Oak Hill Avenue
Attleboro, MA 02703**

Prepared by:
Massachusetts Department of Public Health
Center for Environmental Health
Bureau of Environmental Health Assessment
Emergency Response/Indoor Air Quality Program
September 2004

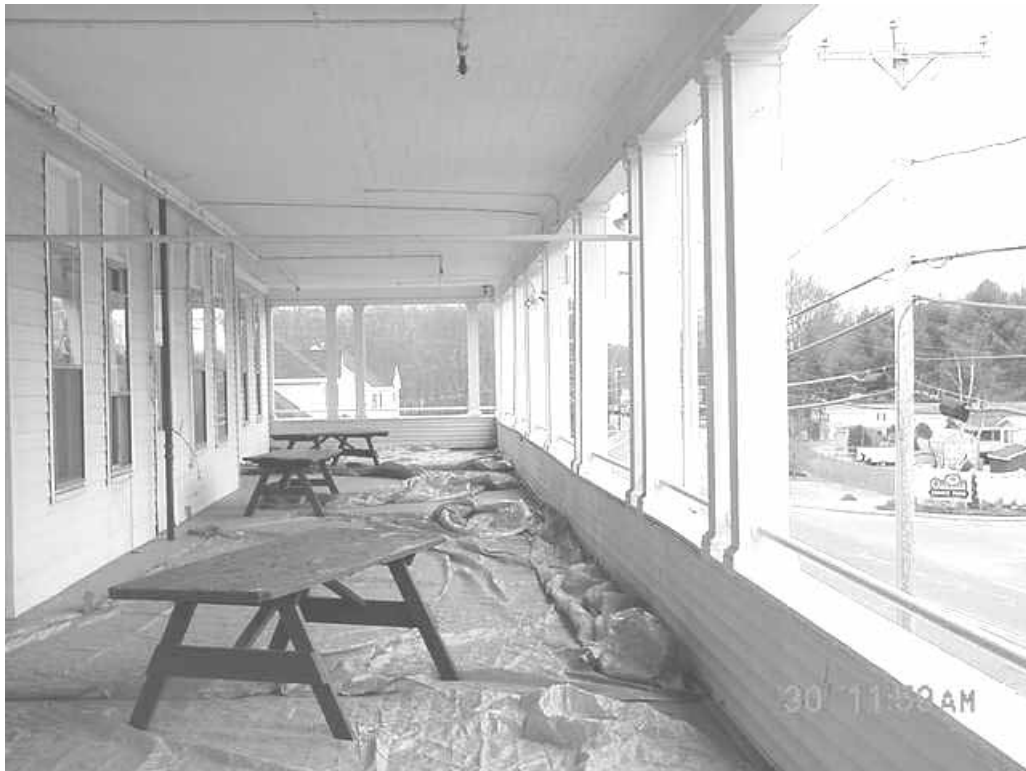
Picture 1

As previously stated, water-damaged building materials were mold-colonized as a result of water infiltration, mainly through breaches in the porch above the laundry room. At the time of the assessment, the porch was covered with a tarpaulin to prevent additional damage until repairs resumed (Picture 1). Visible mold growth on a number of porous and non-porous surfaces was observed by BEHA staff. These included ceiling and wall plaster, wooden slats and metal pipes (Pictures 2-4). Breaches (e.g., utility holes) were noted in the basement ceiling (Picture 5) that can serve as pathways for movement of odors and particulates between the basement and first floor. Mold and related particulates can be irritating to sensitive individuals. To prevent mold-related

Porch Area Covered With Tarpaulins

1. Continue with plans to make repairs to porch to prevent further water penetration.
2. Repair gutters and downspouts to direct rainwater away from the building.
3. Repair breaches in the building envelope (e.g., utility holes).
4. Remove clinging plants from exterior walls of building.

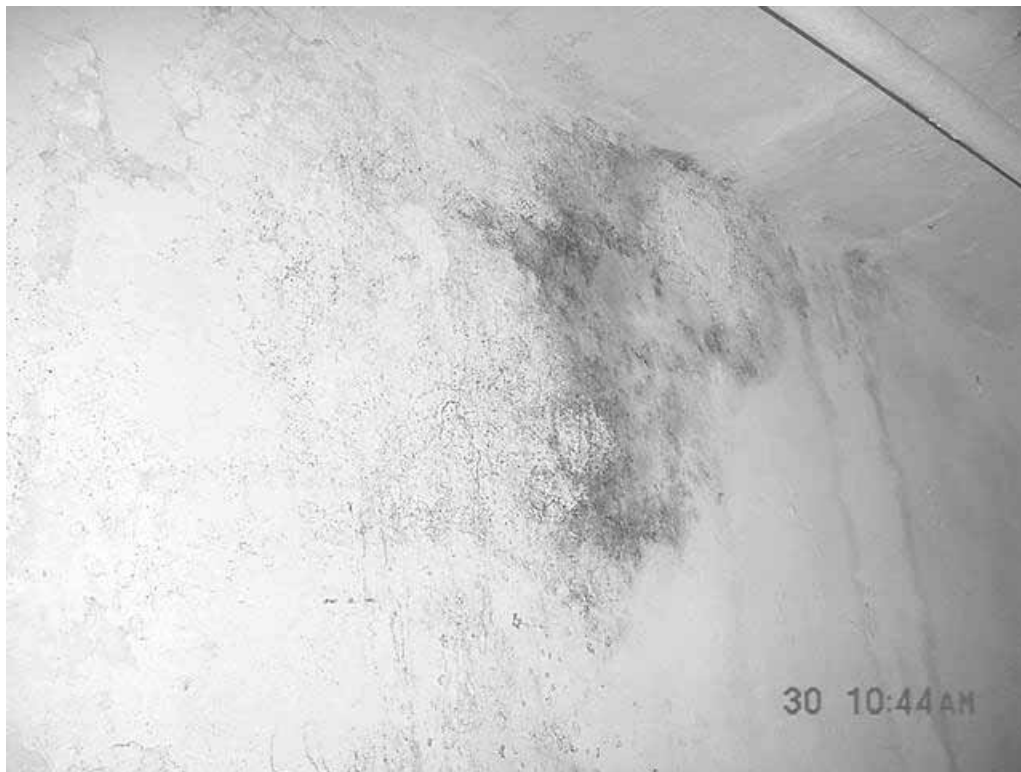
Picture 2

Visible Mold Growth on Wall Plaster

1. Remove mold contaminated materials in a manner consistent with recommendations found in “Mold Remediation in Schools and Commercial Buildings” published by the US EPA (US EPA, 2001). The document is available at the US EPA website at: http://www.epa.gov/iaq/molds/mold_remediation.html.
2. Identify and seal any utility holes, chase ways or other openings between the basement and first floor (Picture 5).

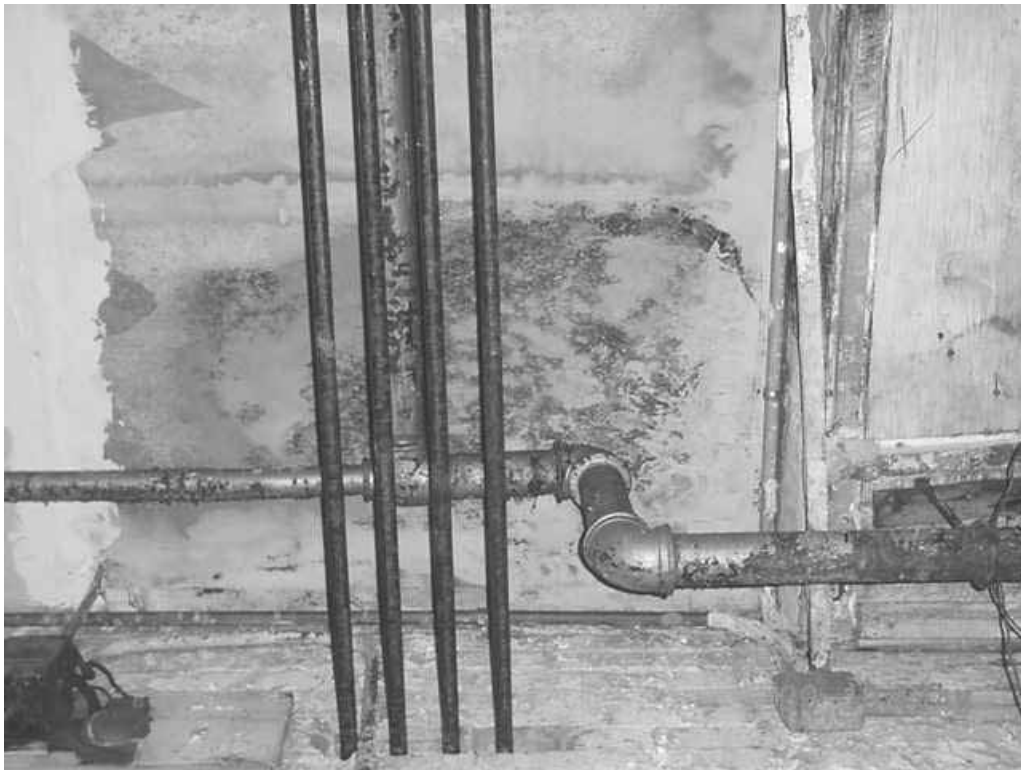
Picture 3

Visible Mold Growth on Plaster Ceiling

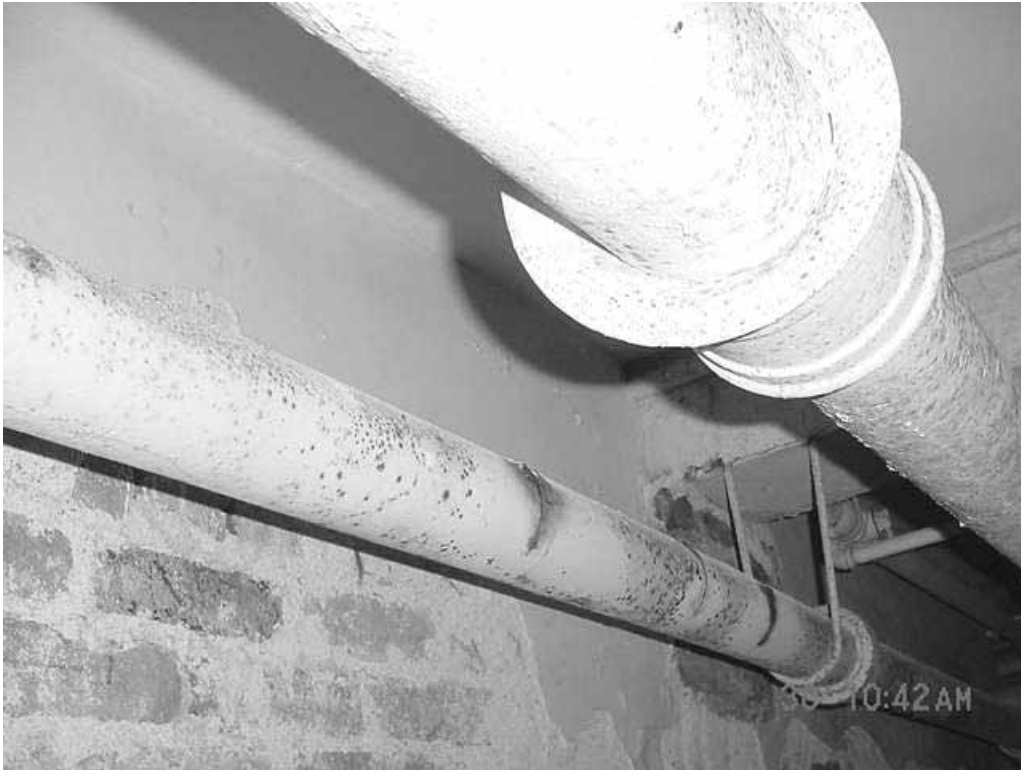
Picture 4

Visible Mold Growth on Iron Pipes

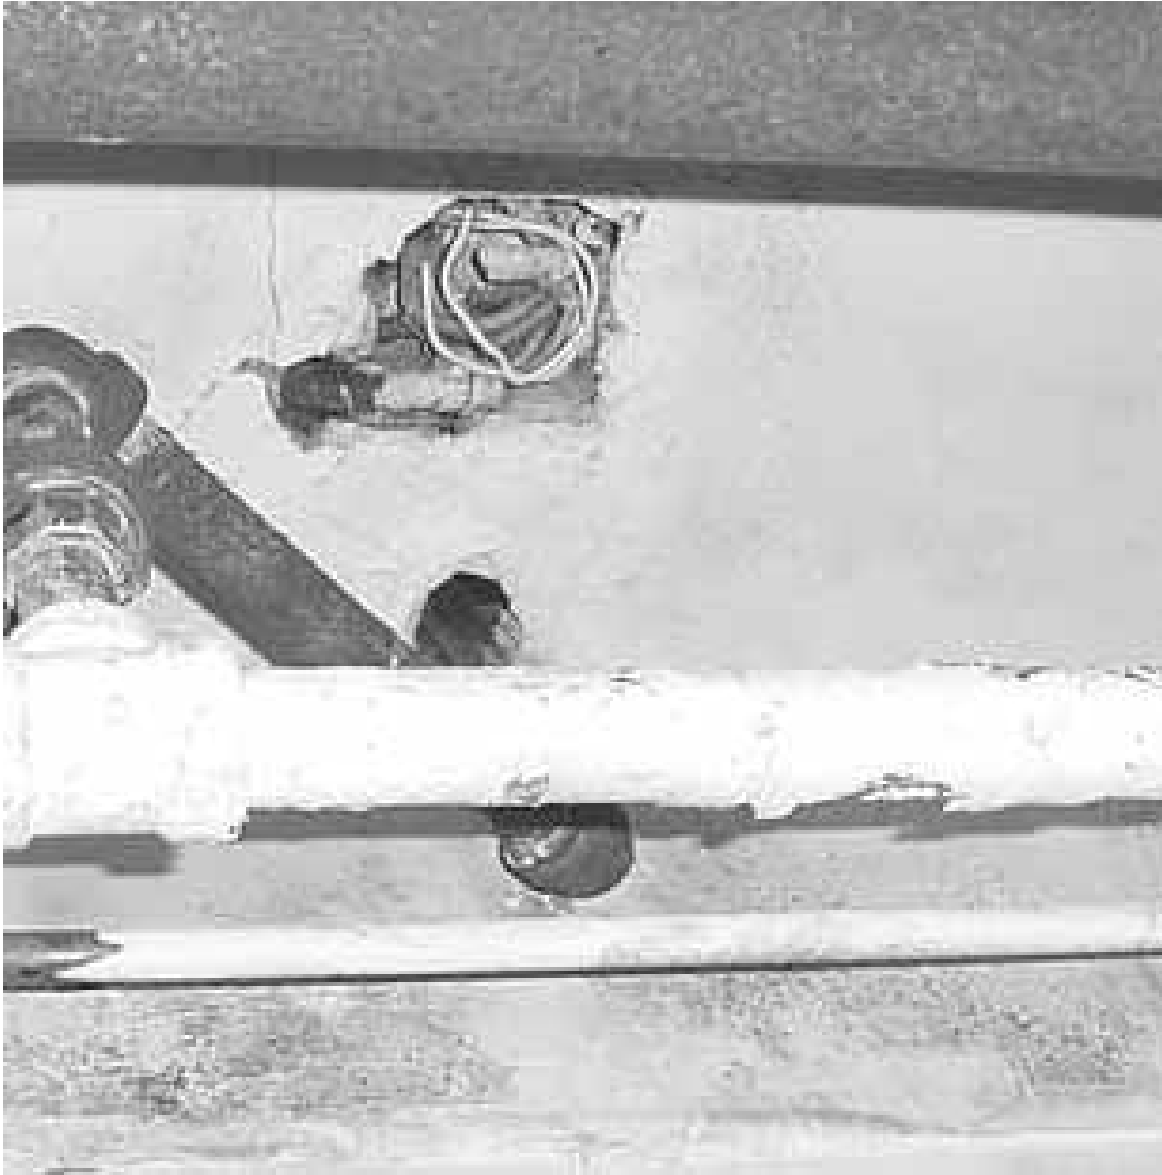
Picture 5

**Open Utility Holes in Basement Ceiling, Note Mold Growth at Bottom of Photo,
Indicated by Black Staining**

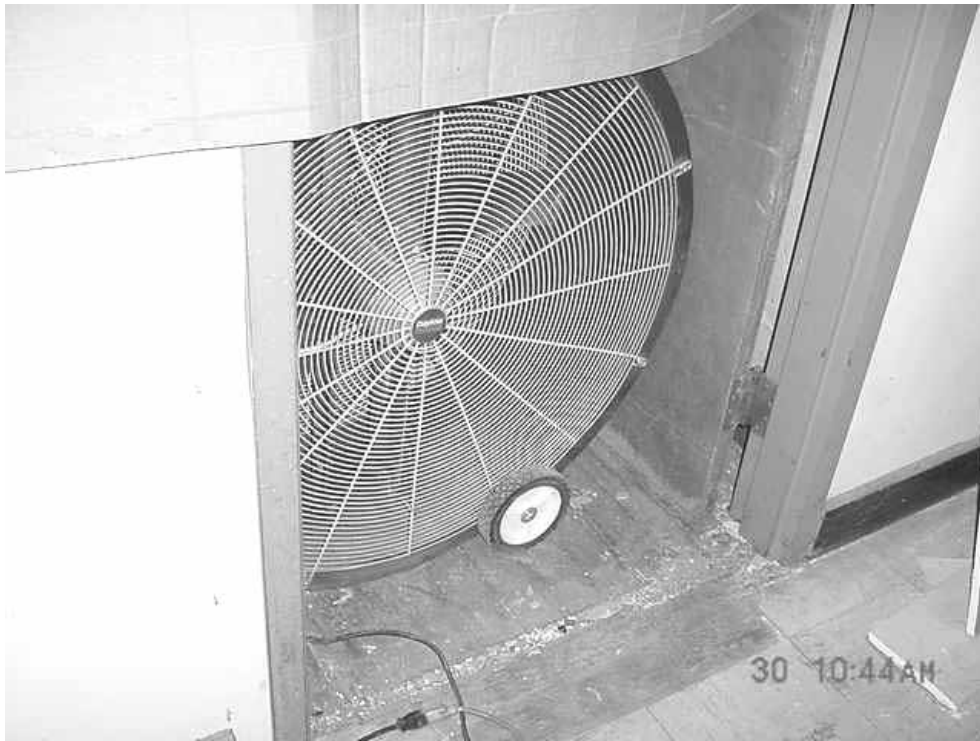
Picture 6

odors from migrating to occupied areas of the building, the basement was sealed and depressurized through the operation of a commercial grade fan (Picture 6).

Commercial Grade Fan in Basement

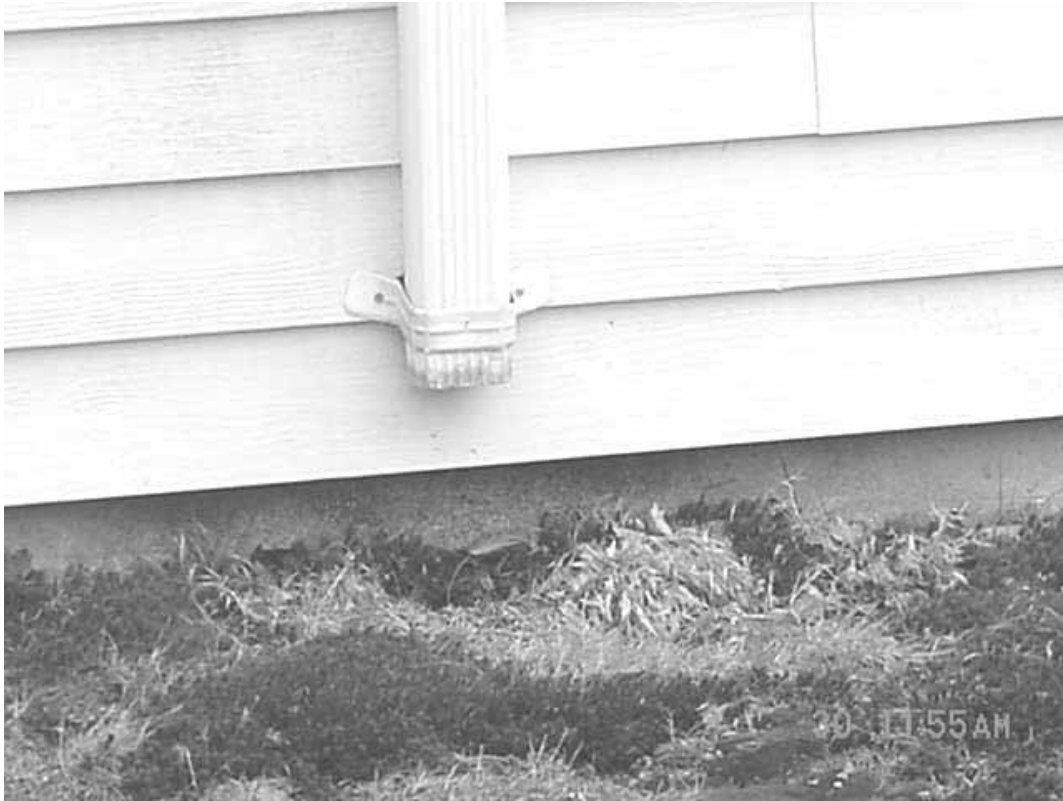
Picture 7

- Damaged/dislodged gutters and downspouts around the perimeter of the building (Picture 7);
- Heavy moss growth along the perimeter of the building, indicating an area of chronic water accumulation (Picture 8);
- Clinging plants growth on exterior walls in several areas (Picture 9). Clinging plants can cause water damage to brickwork, as tendrils are inserted into brick and mortar. Water can penetrate into the brick along the tendrils and subsequently freeze and thaw during the winter. This freezing/thawing action can weaken brick and mortar, resulting in damage to this wall; and
- Open utility holes (Picture 10), which can provide entry for rodents and other pests.

Downspout Missing Elbow Extension Emptying Water Against Foundation

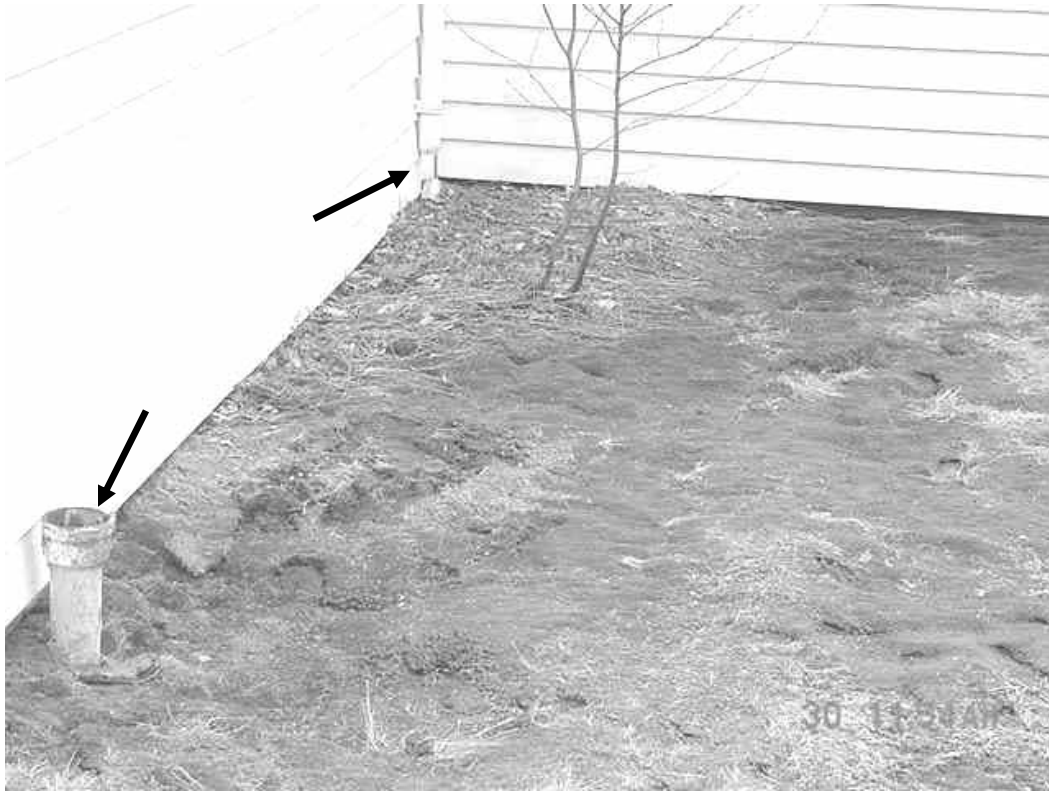
Picture 8

Heavy Moss Growth in Interior Corner of Building, Note Missing Downspout and Elbow Extension

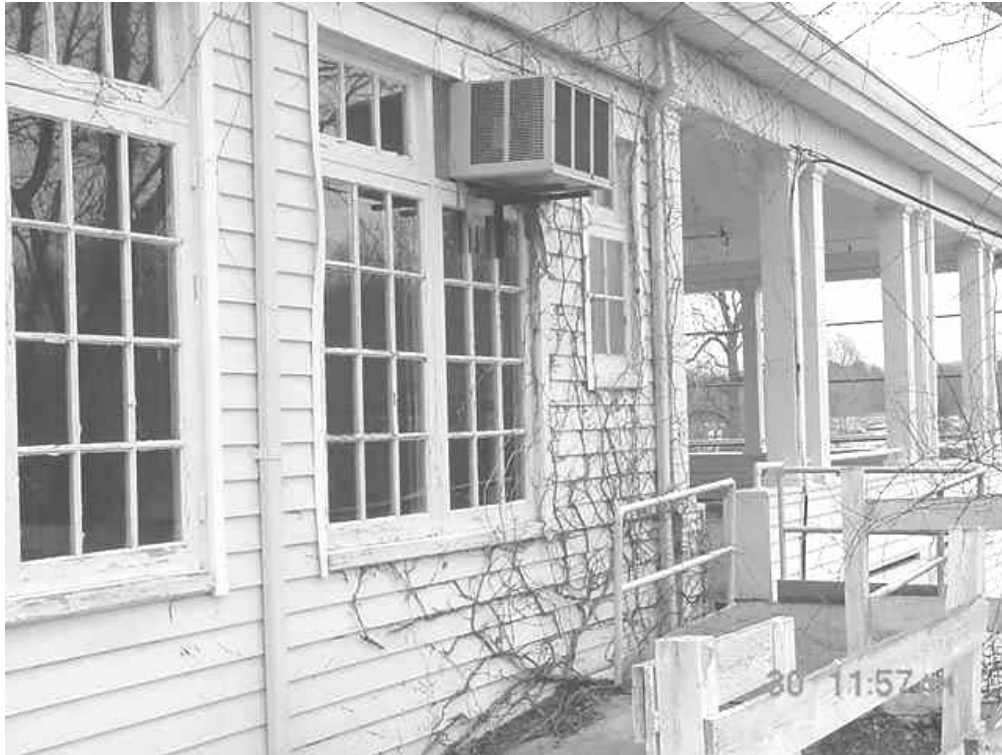
Picture 9

Crawling Plants on Side of Building

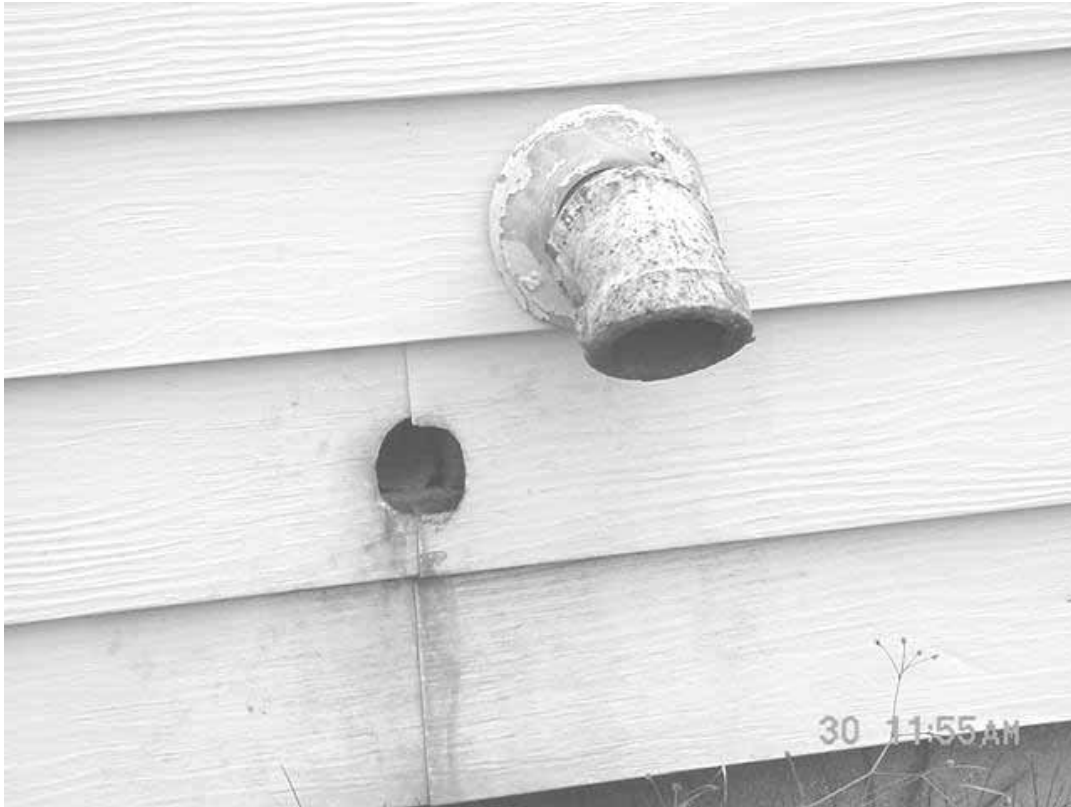
Picture 10

Open Utility Hole

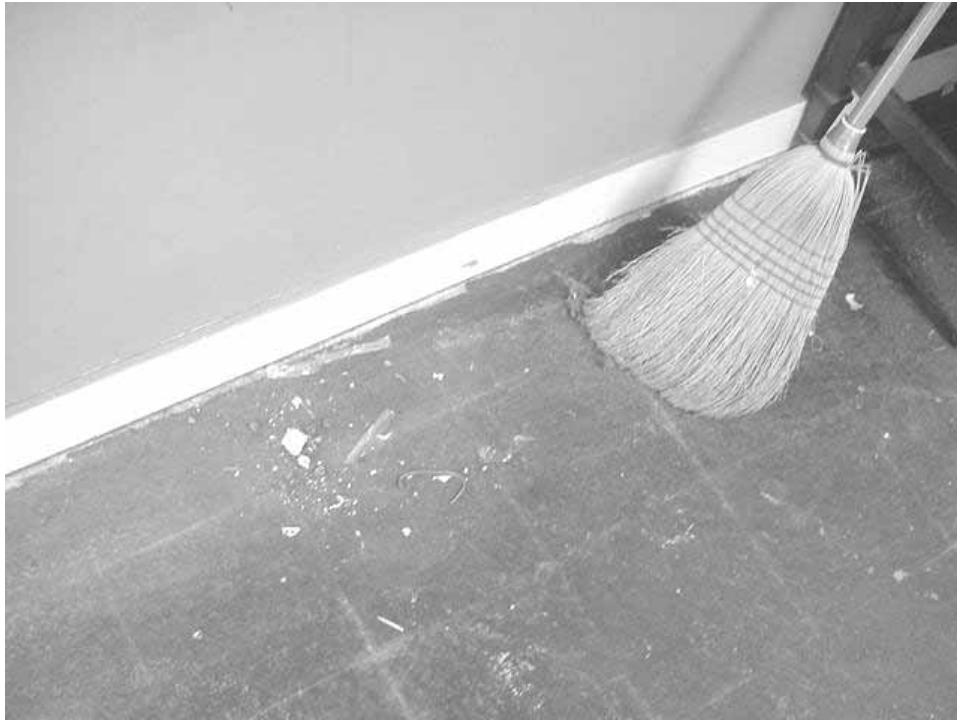
Picture 11

Outdoor PM_{2.5} concentrations were measured at $20 \mu\text{g}/\text{m}^3$ (Table 1). PM_{2.5} levels measured indoors ranged from 16 to $86 \mu\text{g}/\text{m}^3$. Frequently, indoor air levels of particulates (including PM_{2.5}) can be at higher levels than those measured outdoors. A number of mechanical devices and/or activities that occur in schools can generate particulate during normal operations. Sources of indoor airborne particulates may include but are not limited to particles generated during the operation of fan belts in the HVAC system, cooking in the cafeteria stoves and microwave ovens; use of photocopiers, fax machines and computer printing devices; operation of an ordinary vacuum cleaner and heavy foot traffic indoors. The highest PM_{2.5} measurement was taken in classroom 6B. Airborne levels of fine particulate were most likely elevated due to sweeping of the classroom floor by occupants (Picture 11).

Evidence of Sweeping causing Elevated Airborne Particulates in Classroom 6B
